Taconite Harbor Advisory Committee Environmental Context

December 17, 2025

Environmental Context

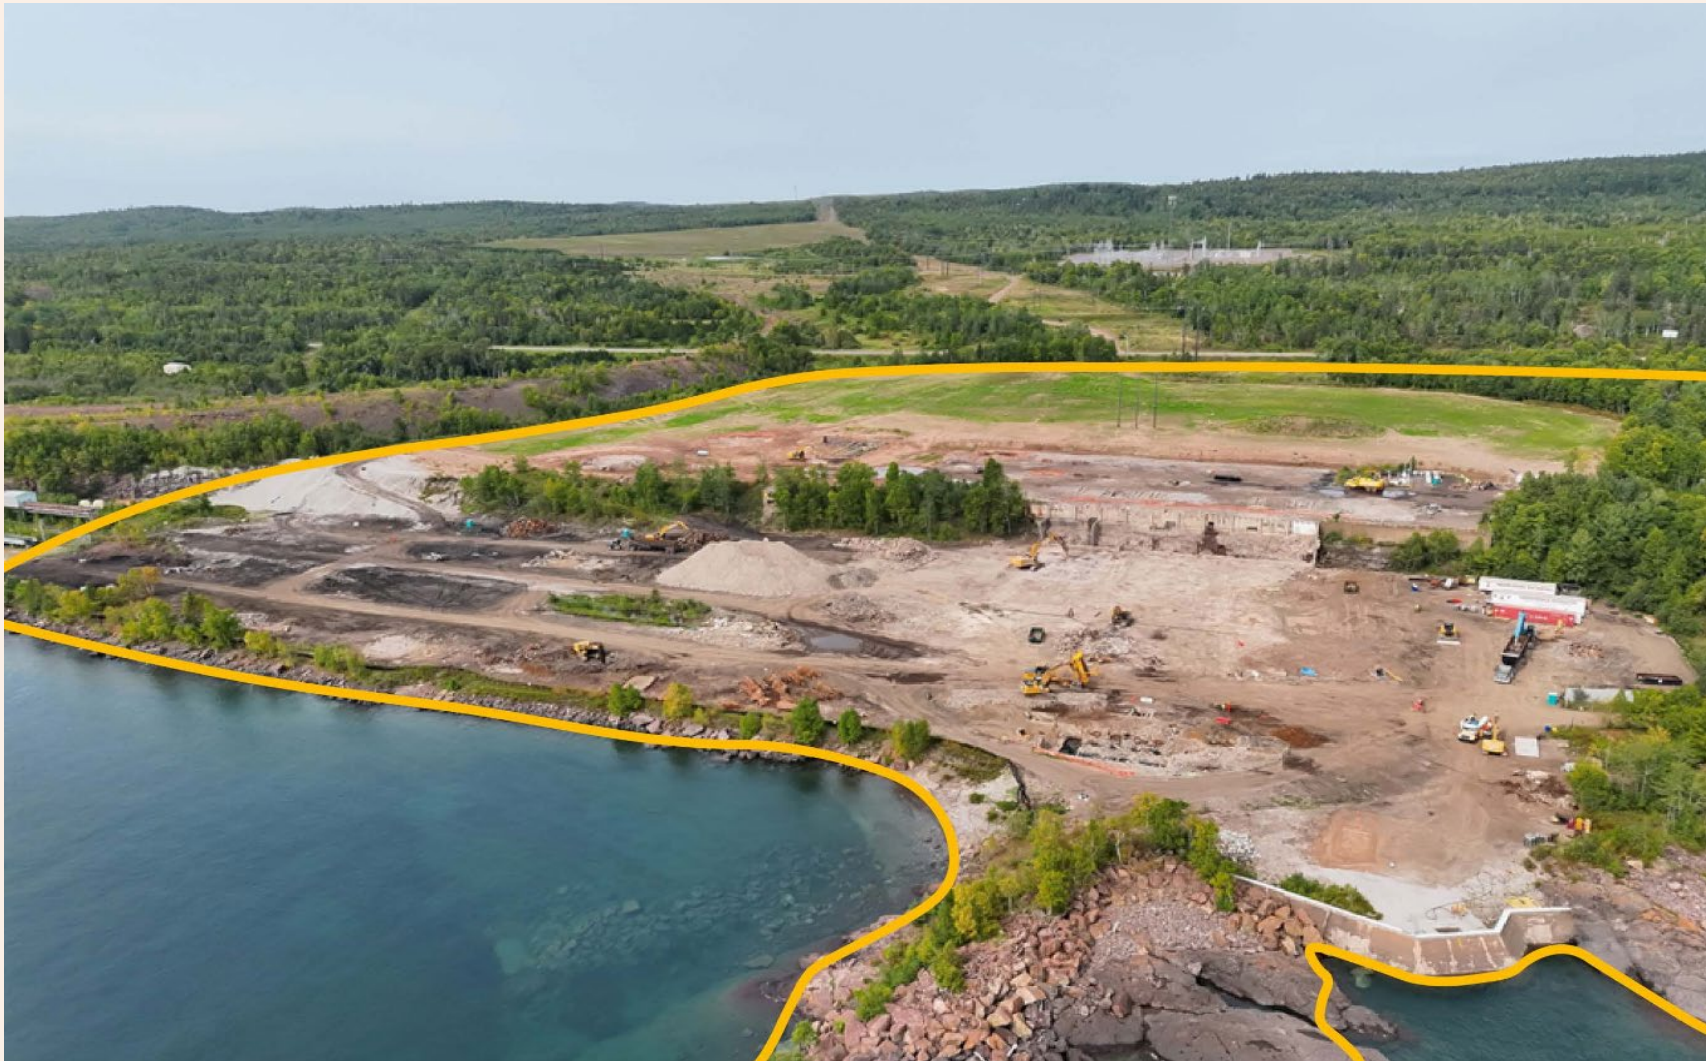
- Land Cover
- Threatened and Endangered Species
- Water Resources
- Geology
- Soils
- Northshore Management Zone & Bluff Requirements

**Not current conditions.*

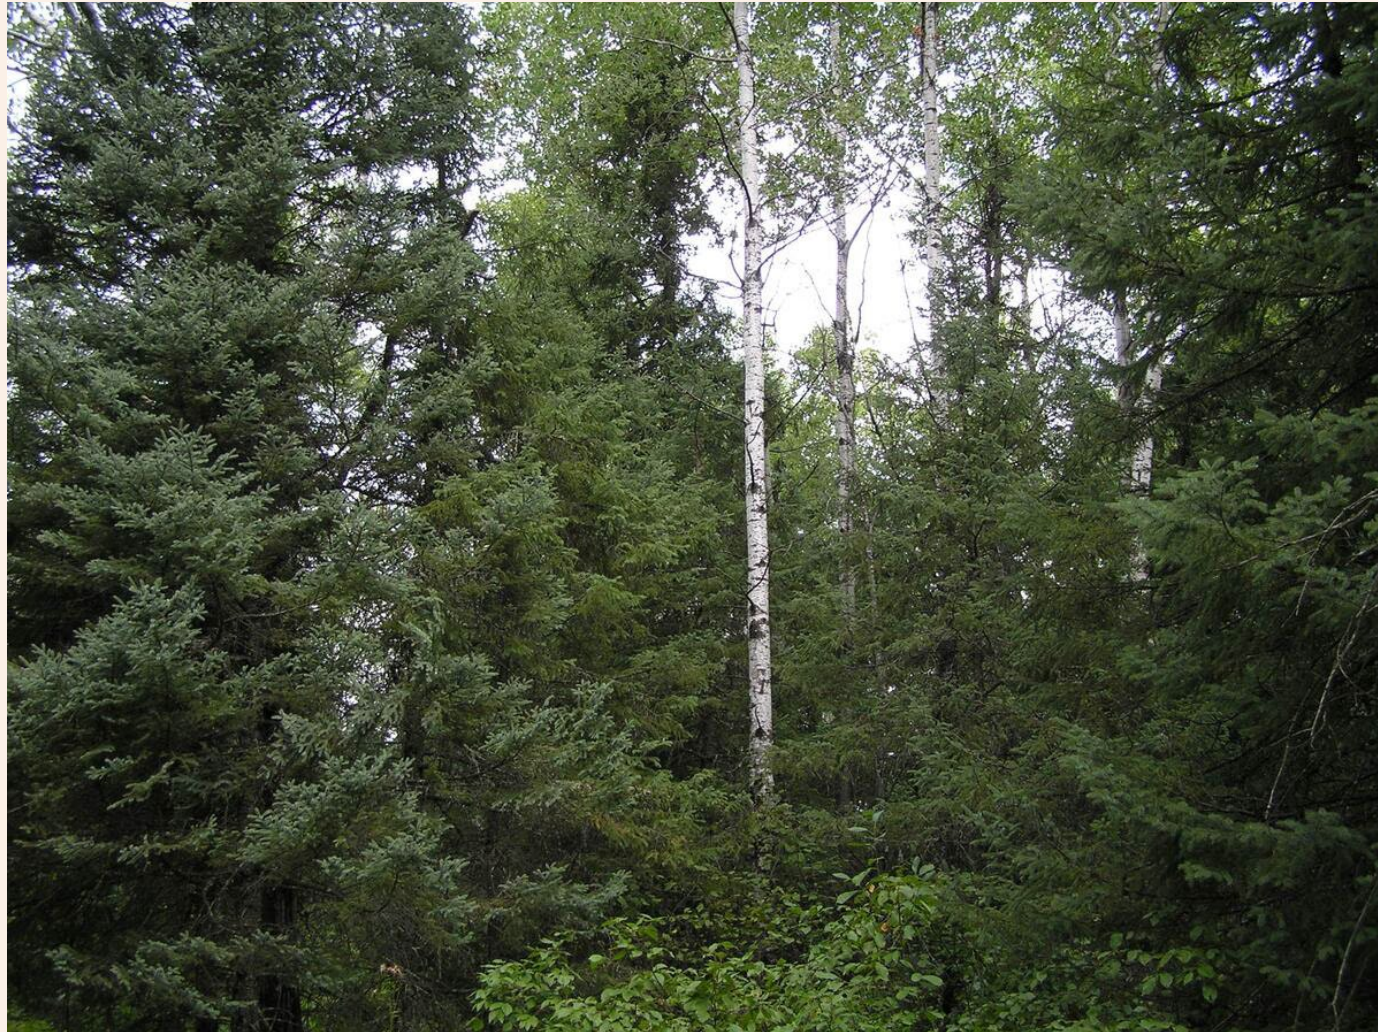
Land Cover – Native Vegetation

Pre-Settlement Vegetation:

- Boreal Hardwood Conifer Forest
- Aspen-Birch (trending to Conifers)
- Fire played a major role in shaping these forests, creating a mosaic of young aspen-birch stands.

Existing Conditions:

- Some natural forest regrowth
- Some areas with scarce to no vegetation

Native Plant Communities:

- Wet Rocky Shore
- Gravel/Cobble Beach

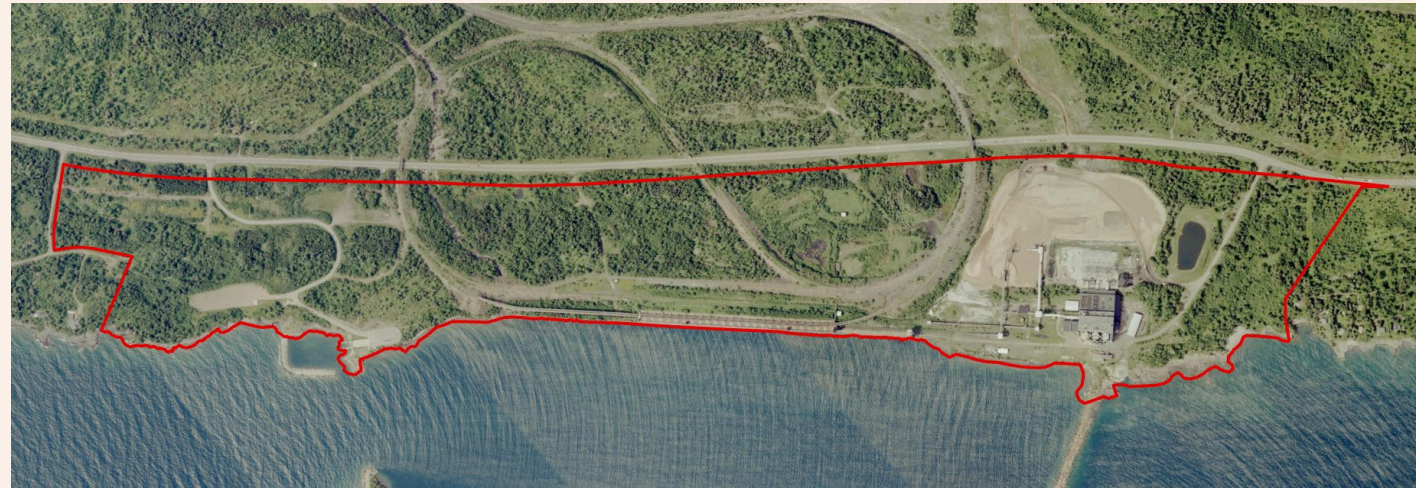
Land Cover – Existing Conditions

Current landcover consists of:

- Deciduous forest
- Mixed forest (conifers and deciduous)
- Emergent and woody wetlands
- Barren land (rock/soils)
- Developed area (roads, buildings, infrastructure)
- Open water

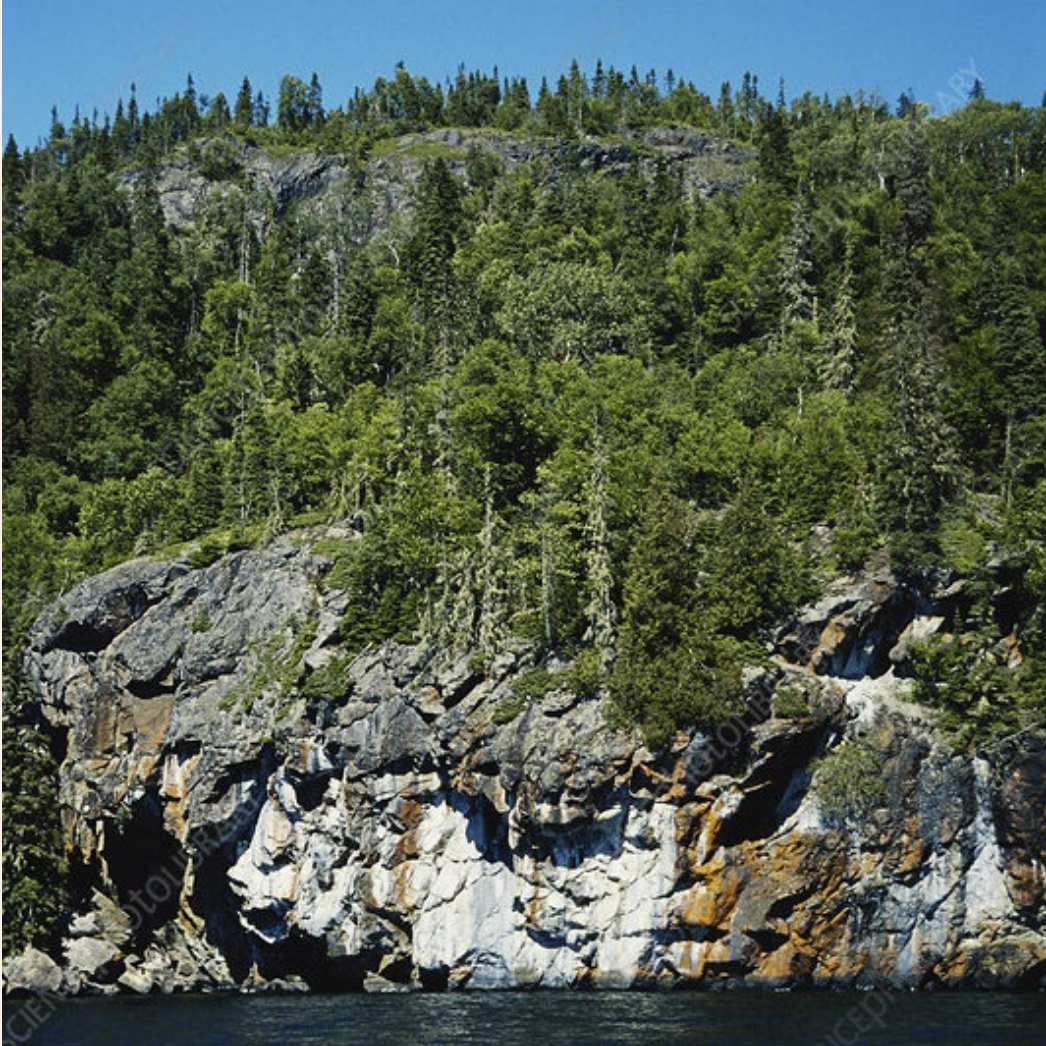
Geology

Bedrock Geology:

The geology below the surface is 1.1-billion-year-old volcanic rock called basalt. These specific basalts are called the ***Schroeder basalts*** and they makeup much of Lake Superiors rocky shoreline.

Surficial Geology:

The native geology at the surface was primarily deposited during the latest glaciation (35,000 years ago) but also includes deposits from the rise and fall of Lake Superior and from streams.

Surficial geology onsite consists of:

- Glacial Till
- Glacial Silt and Clay
- Beach and Nearshore Sand
- Floodplain and Fluvial Sand and Silt
- Non-Native Constructed Land (deposited by industrial activities)
